# Geology and Soils Technical Study Mission San Marcos Industrial Park

528 East Mission Road

San Diego, California

Helix Project No. 04658.00002.001

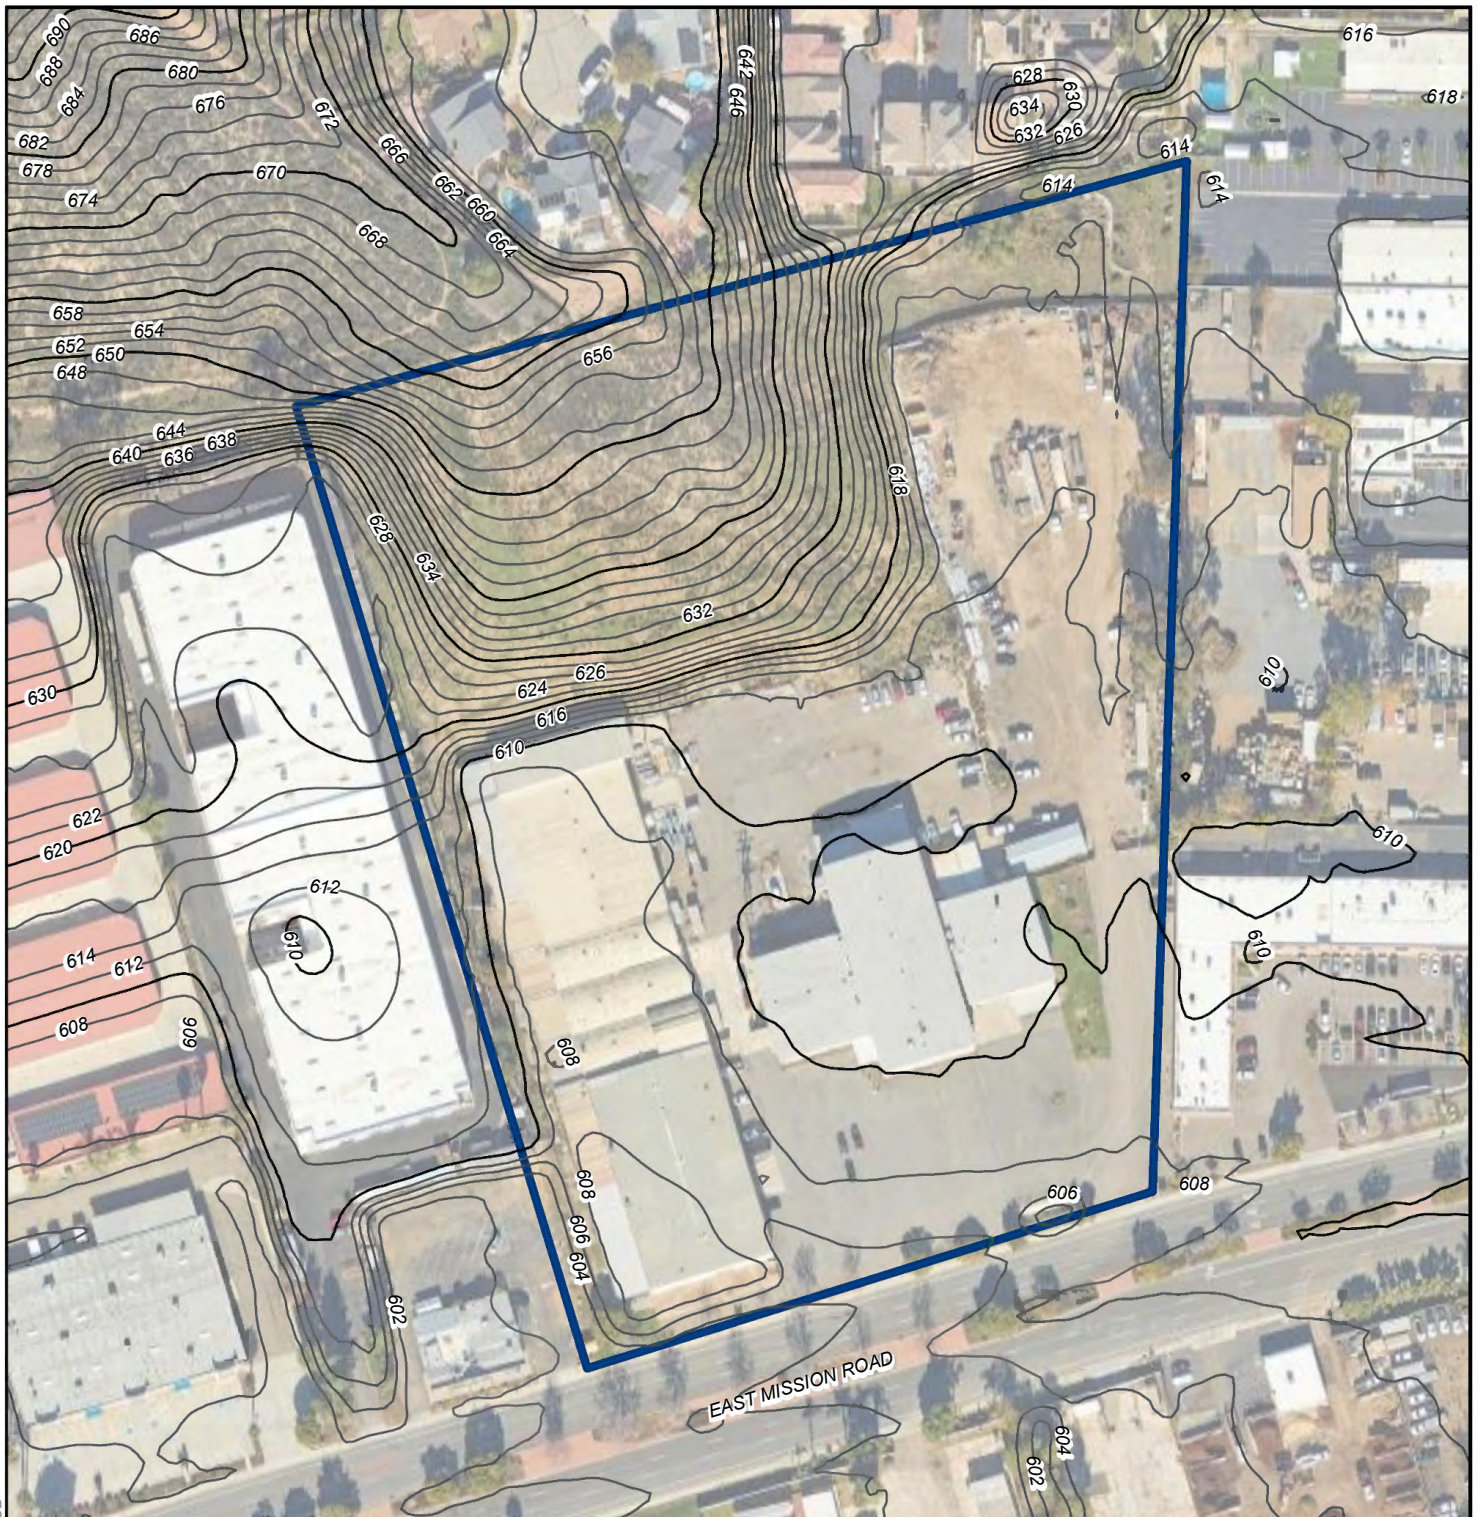
109768001 | 5/24

- SITE BOUNDARY
- 690 TOPOGRAPHIC CONTOURS (NOAA, 2014)

MISSION SAN MARCOS INDUSTRIAL PARK  
528 EAST MISSION ROAD  
SAN MARCOS, CALIFORNIA

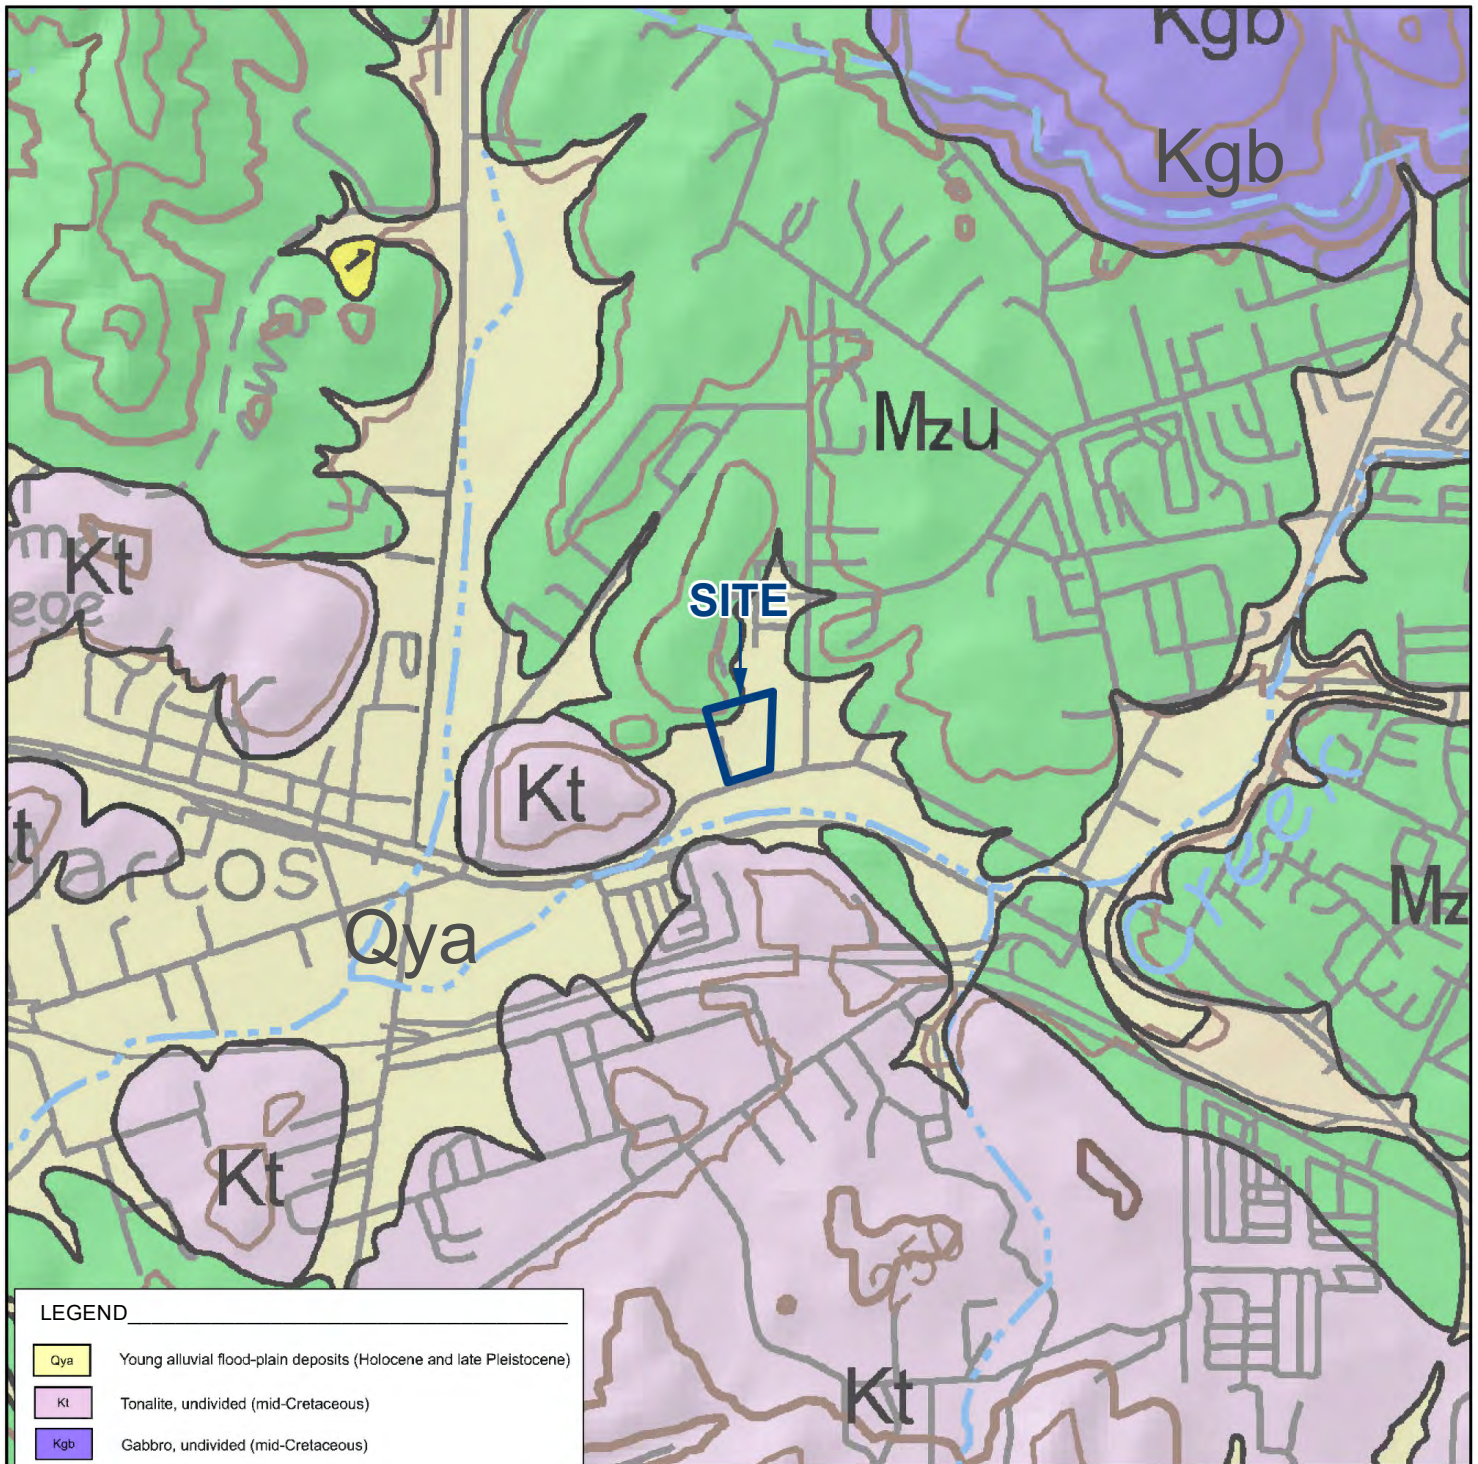
109768001 | 5/24

- Qya Young alluvial flood-plain deposits (Holocene and late Pleistocene)
- Kt Tonalite, undivided (mid-Cretaceous)
- Kgb Gabbro, undivided (mid-Cretaceous)
- Mzu Metasedimentary and metavolcanic rocks, undivided (Mesozoic)
- Q1s? Landslide - Arrows indicate principal direction of movement. Queried where existence is questionable.
- Fault - Solid where accurately located; dashed where approximately located; dotted where concealed. U = upthrown block, D = downthrown block. Arrow and number indicate direction and angle of dip of fault plane.
- Strike and dip of beds

Based on our review of published geologic maps, geotechnical boring logs (Geocon, 2020) and our site reconnaissance, surficial soils at the project site consist of fill, alluvium, and metasedimentary/metavolcanic bedrock (Kennedy et al., 2007; Figure 4). No significant geologic features at the site will be impacted by the project. A brief description of these units, as described in the cited literature or as observed on the site, is presented below.

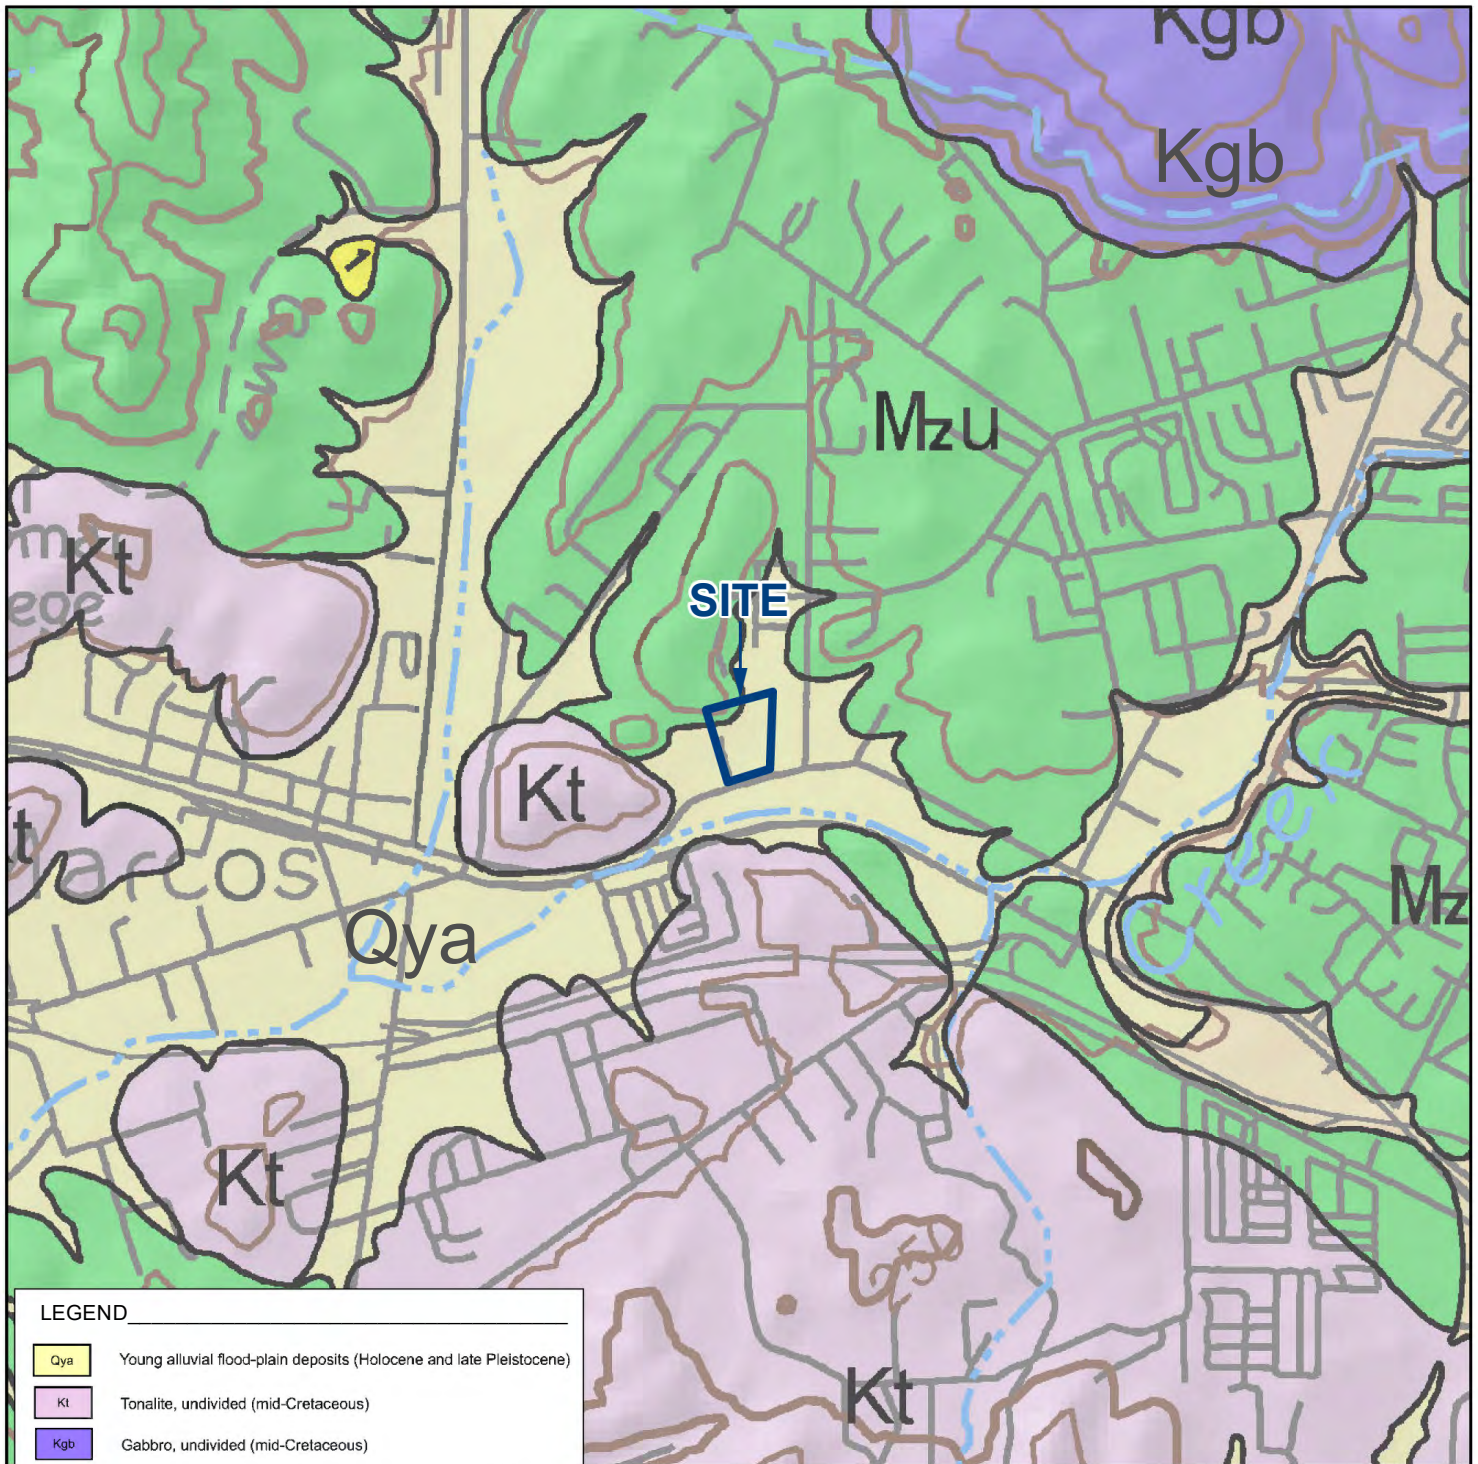
REFERENCE: KENNEDY, M.P., TAN, S.S., 2007, GEOLOGIC MAP OF THE OCEANSIDE 30 X 60-MINUTE QUADRANGLE, CALIFORNIA
